Aviation Investigation Preliminary Report

Location:	Truckee, CA	Accident Number:	WPR24FA119
Date & Time:	March 30, 2024, 18:37 Local	Registration:	N960LP
Aircraft:	Daher TBM700	Injuries:	2 Fatal
Flight Conducted Under:	Part 91: General aviation - Personal

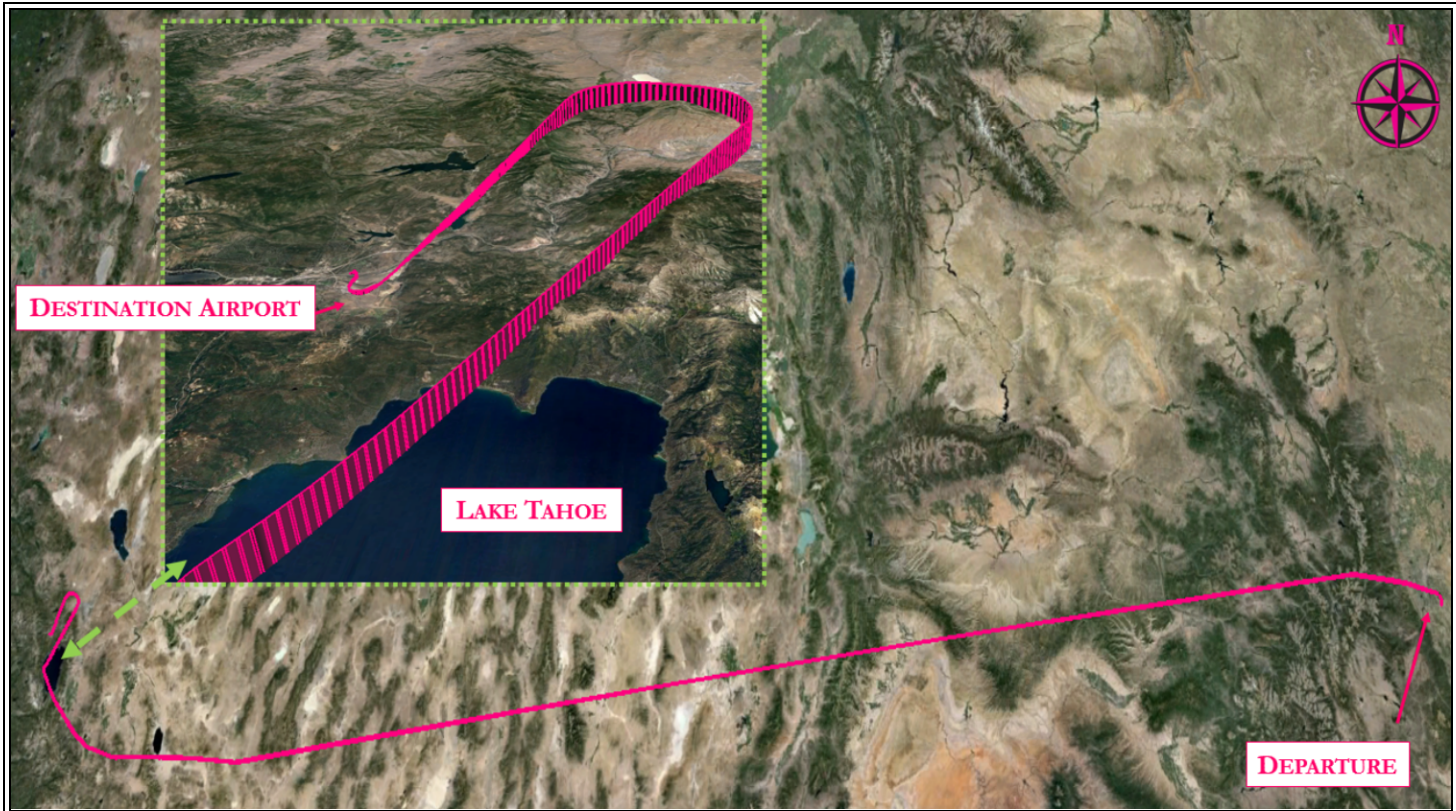
Figure 1: ADS-B Flight Track

The Federal Aviation Administration (FAA) provided automatic dependent surveillance-broadcast (ADS-B) information disclosed that the airplane departed from Centennial Airport in Denver, Colorado about 1525. Following departure, the airplane turned to a westerly heading and eventually climbed to a cruise altitude of about 30,000 feet mean sea level (msl). The airplane continued on that course until reaching about 120 nautical miles (nm) from the Truckee-Tahoe Airport (TRK), Truckee, California. The airplane then made a right turn to the north and gradual descent to about 15,000 ft as it passed over Lake Tahoe (see Figure 1 below). The track then turned to the northeast directed to the Initial Approach Fix (IAF), WUDPA, for the RNAV (GPS) RWY 20 instrument approach.

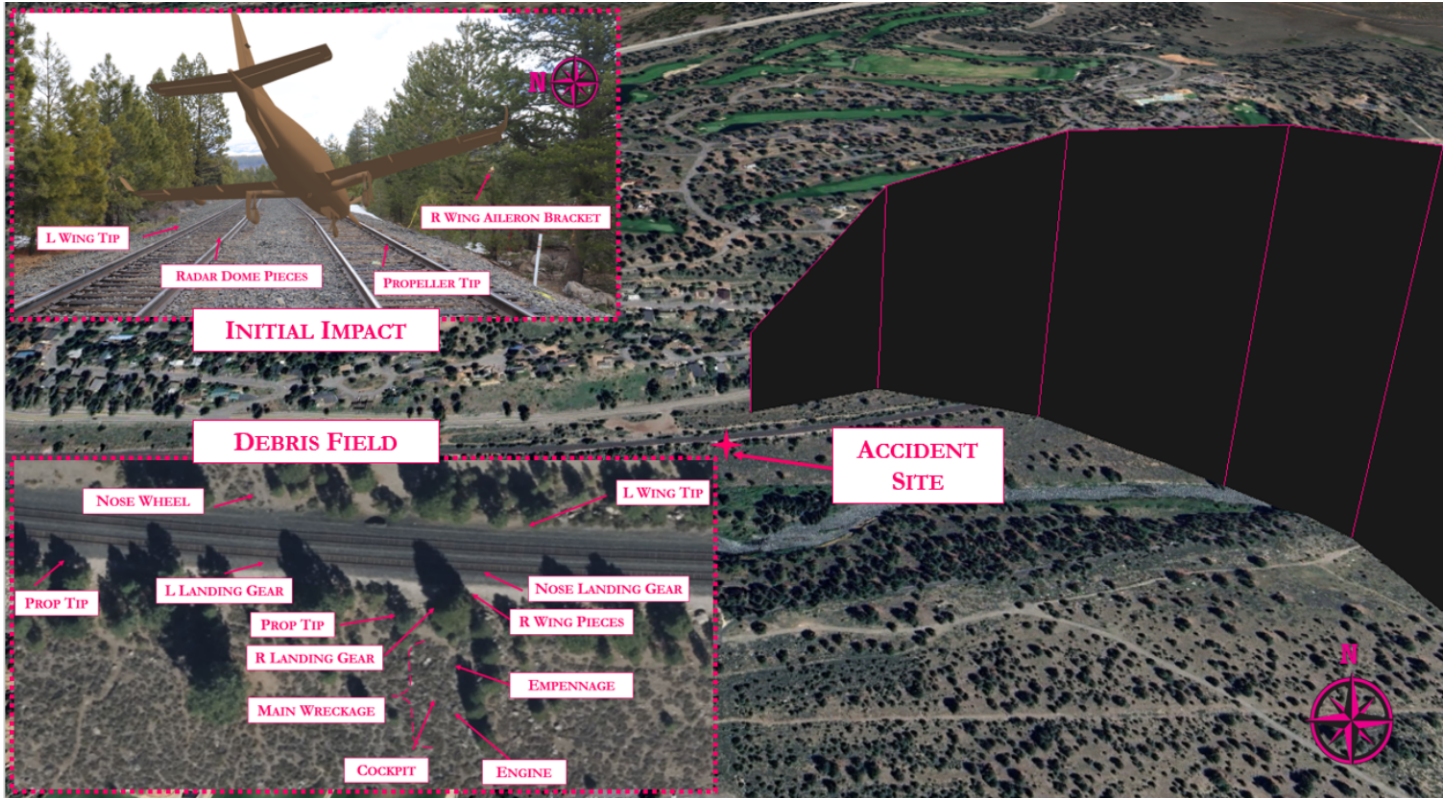
Figure 4: Debris Field and Initial Impact in Reference to the Accident Site

The accident site was located in snow-covered terrain adjacent to railroad tracks about 3,200 ft north from the approach end of runway 11. In character, the terrain was dense thick brush and mature trees. The initial impact area was across four rails with the north area embedded with left-wing tip fragments and the south area had a severed tree with right-wing pieces see Figure 4 below). The initial impact was upslope from the main wreckage, which was located about 100 ft on a heading of 200°. The wreckage was found distributed over 300 ft with the nose wheel tire being one of the farthest pieces of recognizable debris, consistent with the airplane impacting with the landing gear in the extended position. The main wreckage included

the fuselage, inboard wings, empennage, and engine. The fuselage and main cockpit area were severely fragmented and partially consumed by fire, consistent with impact. The Light Data Recorder (LDR) was not located in the wreckage and is presumed to be in the vicinity of the accident site.
