# Aviation Investigation Final Report

<b>Location:</b>	Fairbanks, Alaska	<b>Accident Number:</b>	ANC21LA073
<b>Date &amp; Time:</b>	August 16, 2021, 14:52 Local	<b>Registration:</b>	N97HA
<b>Aircraft:</b>	Cessna 208	<b>Aircraft Damage:</b>	Substantial
<b>Defining Event:</b>	Loss of control in flight	<b>Injuries:</b>	9 None
<b>Flight Conducted Under:</b>	Part 135: Air taxi & commuter - Scheduled

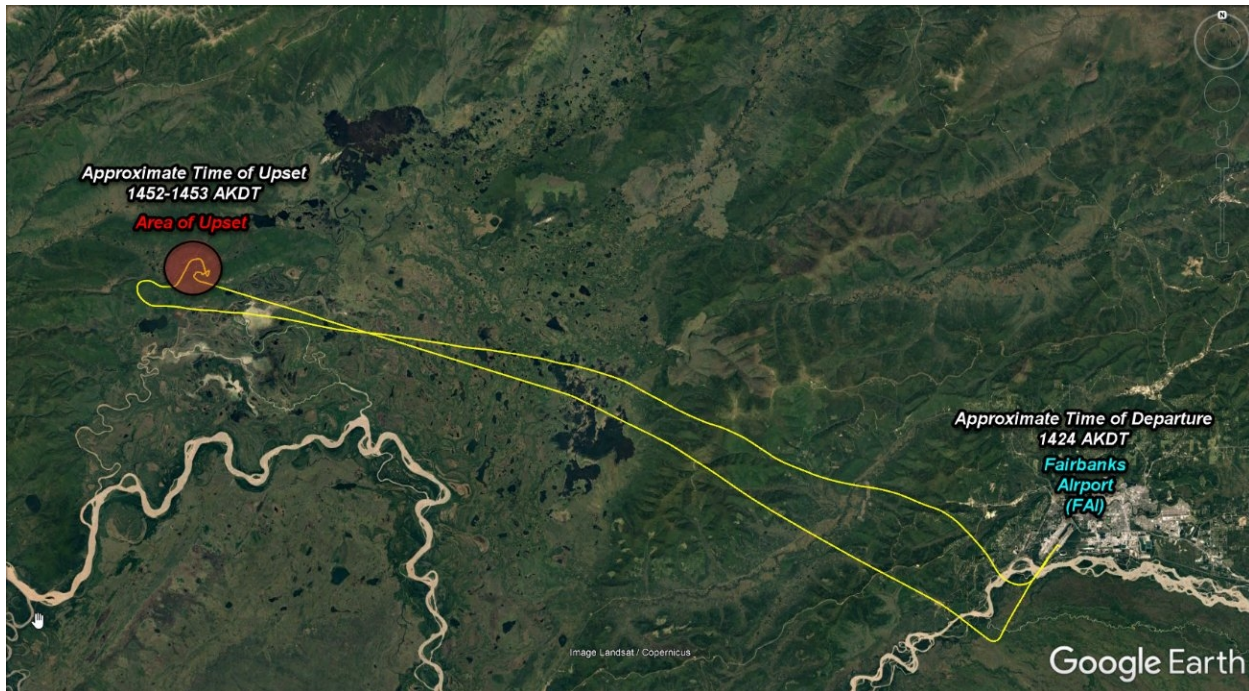
Figure - Flight track.

Flight track data revealed that after departing FAI, the flight proceeded to the west-northwest for about 47 nautical miles cruising at an altitude of about 10,000 ft msl. Before the upset, a climb was initiated, and the flight reached an altitude of about 10,700 ft msl before descending to about 10,300 ft msl followed by an inflight upset with abrupt changes to altitude and speed. (See figure – Flight track.)
